Southwest Home Inspections, LLC

CONFIDENTIAL INSPECTION REPORT

123 Anywhere Ln, Somewhere, USA 12345

SUMMARY REPORT

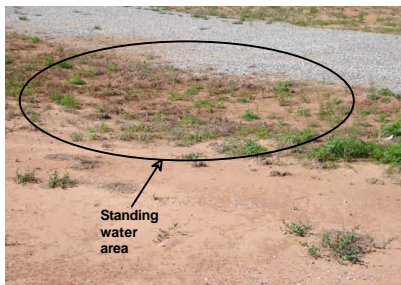
1.1 - There is standing water or debris visible within the area drains, which is indicative of at least a partial blockage. The tendrils of roots may have invaded the drains, but silt also tends to become trapped within the drain pipes and hardens during the summer months to the consistency of wet concrete and creates an impediment that commonly leads to a full blockage. Therefore, we recommend that the lines be flushed through to the street or to their termination point.

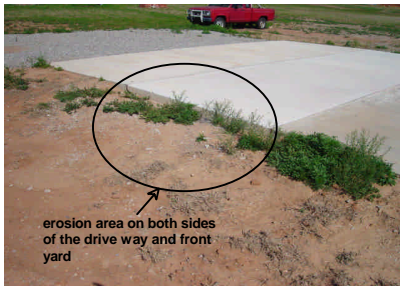
1.2 - The erosion is being caused by fast moving water and is wash away the top soil. Recommend that more soil be used to level off the bad area an grass or heavy gravel be used to prevent this from happening again.

erosion area on both sides of the drive way and front yard

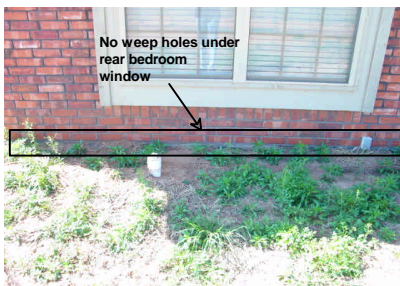
1.3 - The bottom row of bricks are missing the weep holes that are required for moisture drainage. Without these drains installed, the possibility of moisture staying inside the wall system is greatly increased. This could cause mold and mildew to form and cause damage to the home and its occupants. We recommend that the appropriate drainage be installed by a licensed contractor that will not damage the vapor barrier behind the bricks.

No weep holes under rear bedroom window

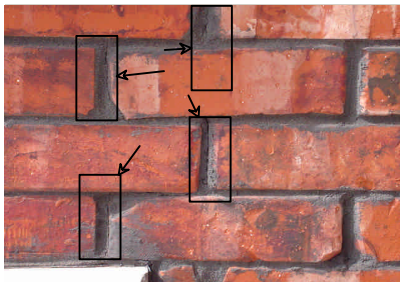
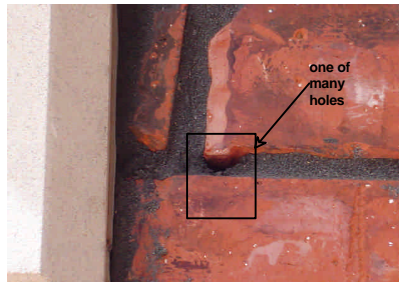
1.4 - Mortar joints need to be re-pointing throughout the brick work to prevent excessive moisture and insect intrusion. Repair should be done by a licensed contractor as soon as possible.

one of many holes

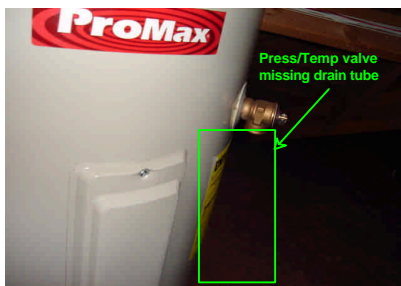
- 5.1 - No pressure temperature relief valve down tube installed. This will caused the water to spray out in an uncontrolled manor that could cause excessive damage to property and people in the immediate area. We recommend that a suitable down tube of the proper material be installed to the current plumbing standards by a licensed contractor.

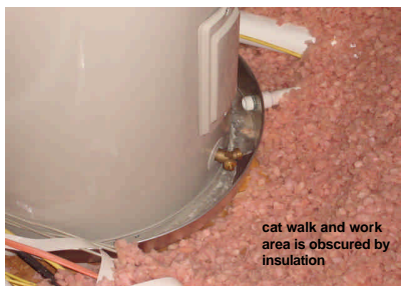
Work area in attic

- 5.2 - Min width for a catwalk is 24"

- 5.3 - There has to be a 30" work space in front of the water heater for servicing the equipment. recommend that a proper platform be constructed by a licensed contractor.

- 5.4 - A 24 in walk around is required for visual inspections and service of the water heater. Recommend that this area be constructed.

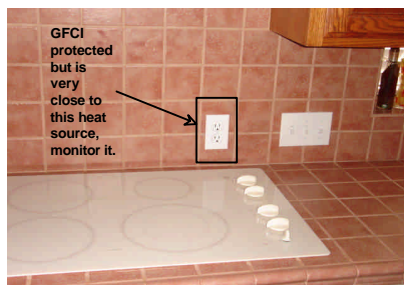
10.1 - There are outlets that are too close to a heat source which needs to be monitored or removed. Heat can cause damage to the outlet and could turn into a shock hazard. We recommend that the owner monitor this outlet because of its proximity of the heat from the cook top.

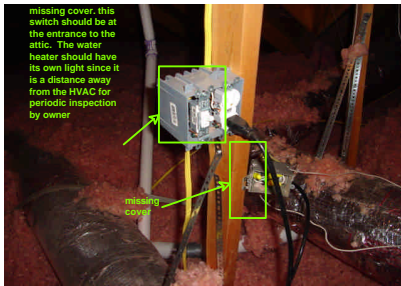
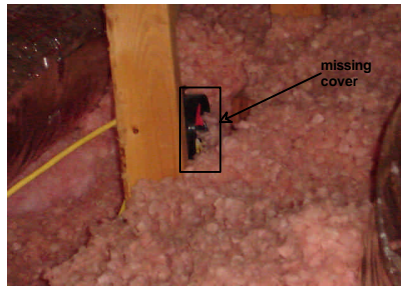
13.2 - There are open electrical junction boxes, which should be sealed to contain any arcing or sparking that might occur Corrections should be done by a licensed electrician..

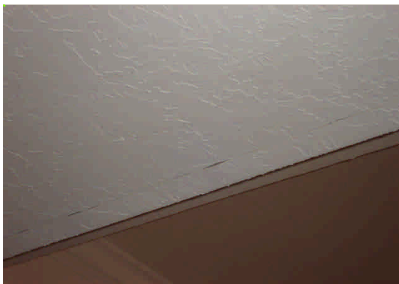
14.1 - The walls or ceiling has significant cracking on the corners. These cracks appears to be from installation not settlement or stress. We recommend that you confirm with a licensed dry wall contractor for repairs and expectation of appearance after they are finished. With textured walls and ceilings it requires specialized skilled laborers to match the old with the new.

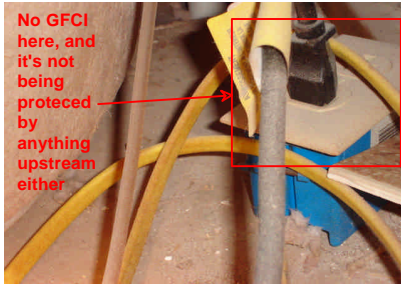
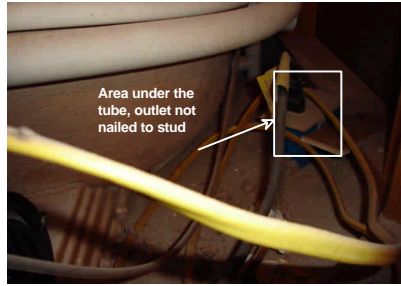
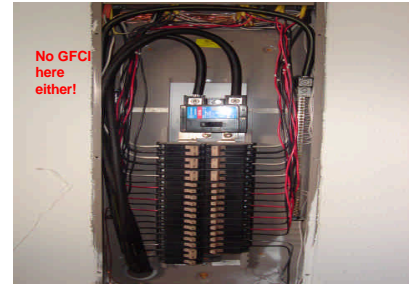
15.1 - The hydro-spa does not appear to have ground fault protection, which is an essential safety feature that should be verified as being present or added. This is a shock hazard that could result in death. We recommend that a GFCI be installed before this hydro-spa is used. We also recommend that the pump motor be unplugged until such repairs are made.

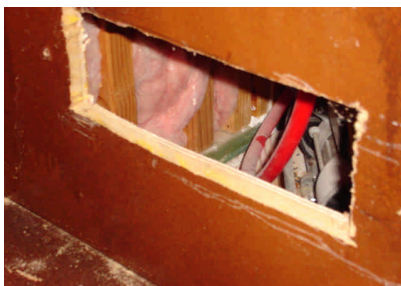
15.2 - There is inadequate access to service the hydro-spa motor, which is essential and should be provided. Also, the hydro-spa motor should be bonded and confirmed to have ground fault protection.

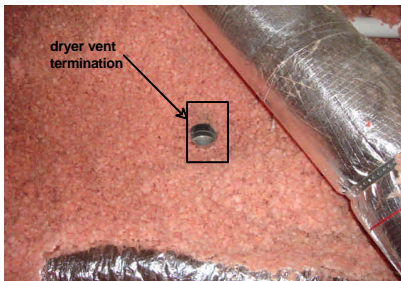
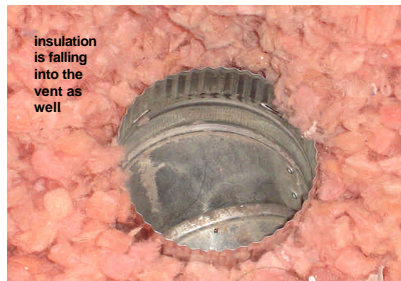
16.2 - Dryer vent terminates into the attic space which will cause excessive moisture build-up especially during cool or cold weather. This can cause damage to the insulation reducing its effectiveness and could cause mold to form in the attic area. We recommend that you have a licensed mechanical contractor vent the dryer in the proper manner.
